# Assembly Line Keeps Rolling as Instant-Set Liquid Membrane Renews Automotive Plant Roof, Defers Costly Replacement

### Project Details

| Project Type | Commercial Built-Up Roof Restoration |

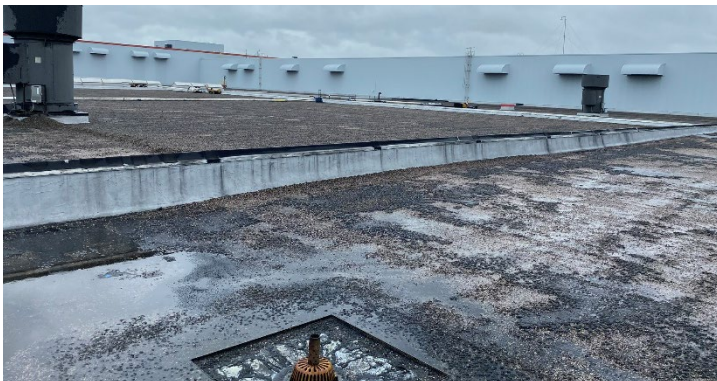
**Before restoration** – Aged modified bitumen roof with multiple penetrations

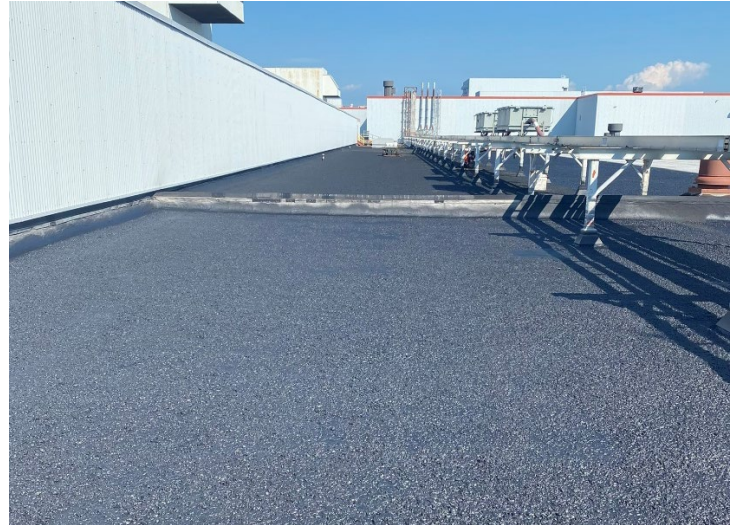
**Elastomeric Membrane** – Ertech 3035 prior to roofing granule application

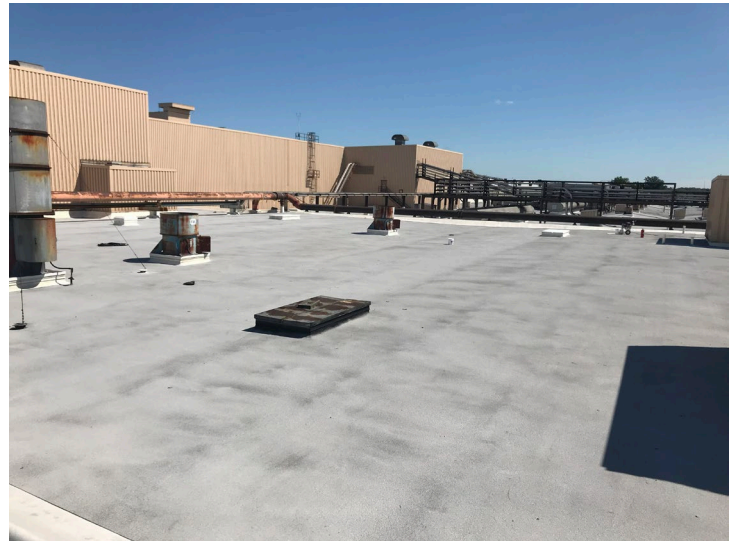
**Finished Restoration** – White roofing granules over Ertech 3036 adhesive
